HAMILTON RUN, HAGERSTOWN, MARYLAND: WATERSHED CHARACTERIZATION AND ACTION PLAN REPORT

Prepared for:

City of Hagerstown
1E. Franklin Street
Hagerstown, MD 21740

Ecosystem Planning and Restoration, LLC
8808 Centre Park Drive
Columbia, MD 21045

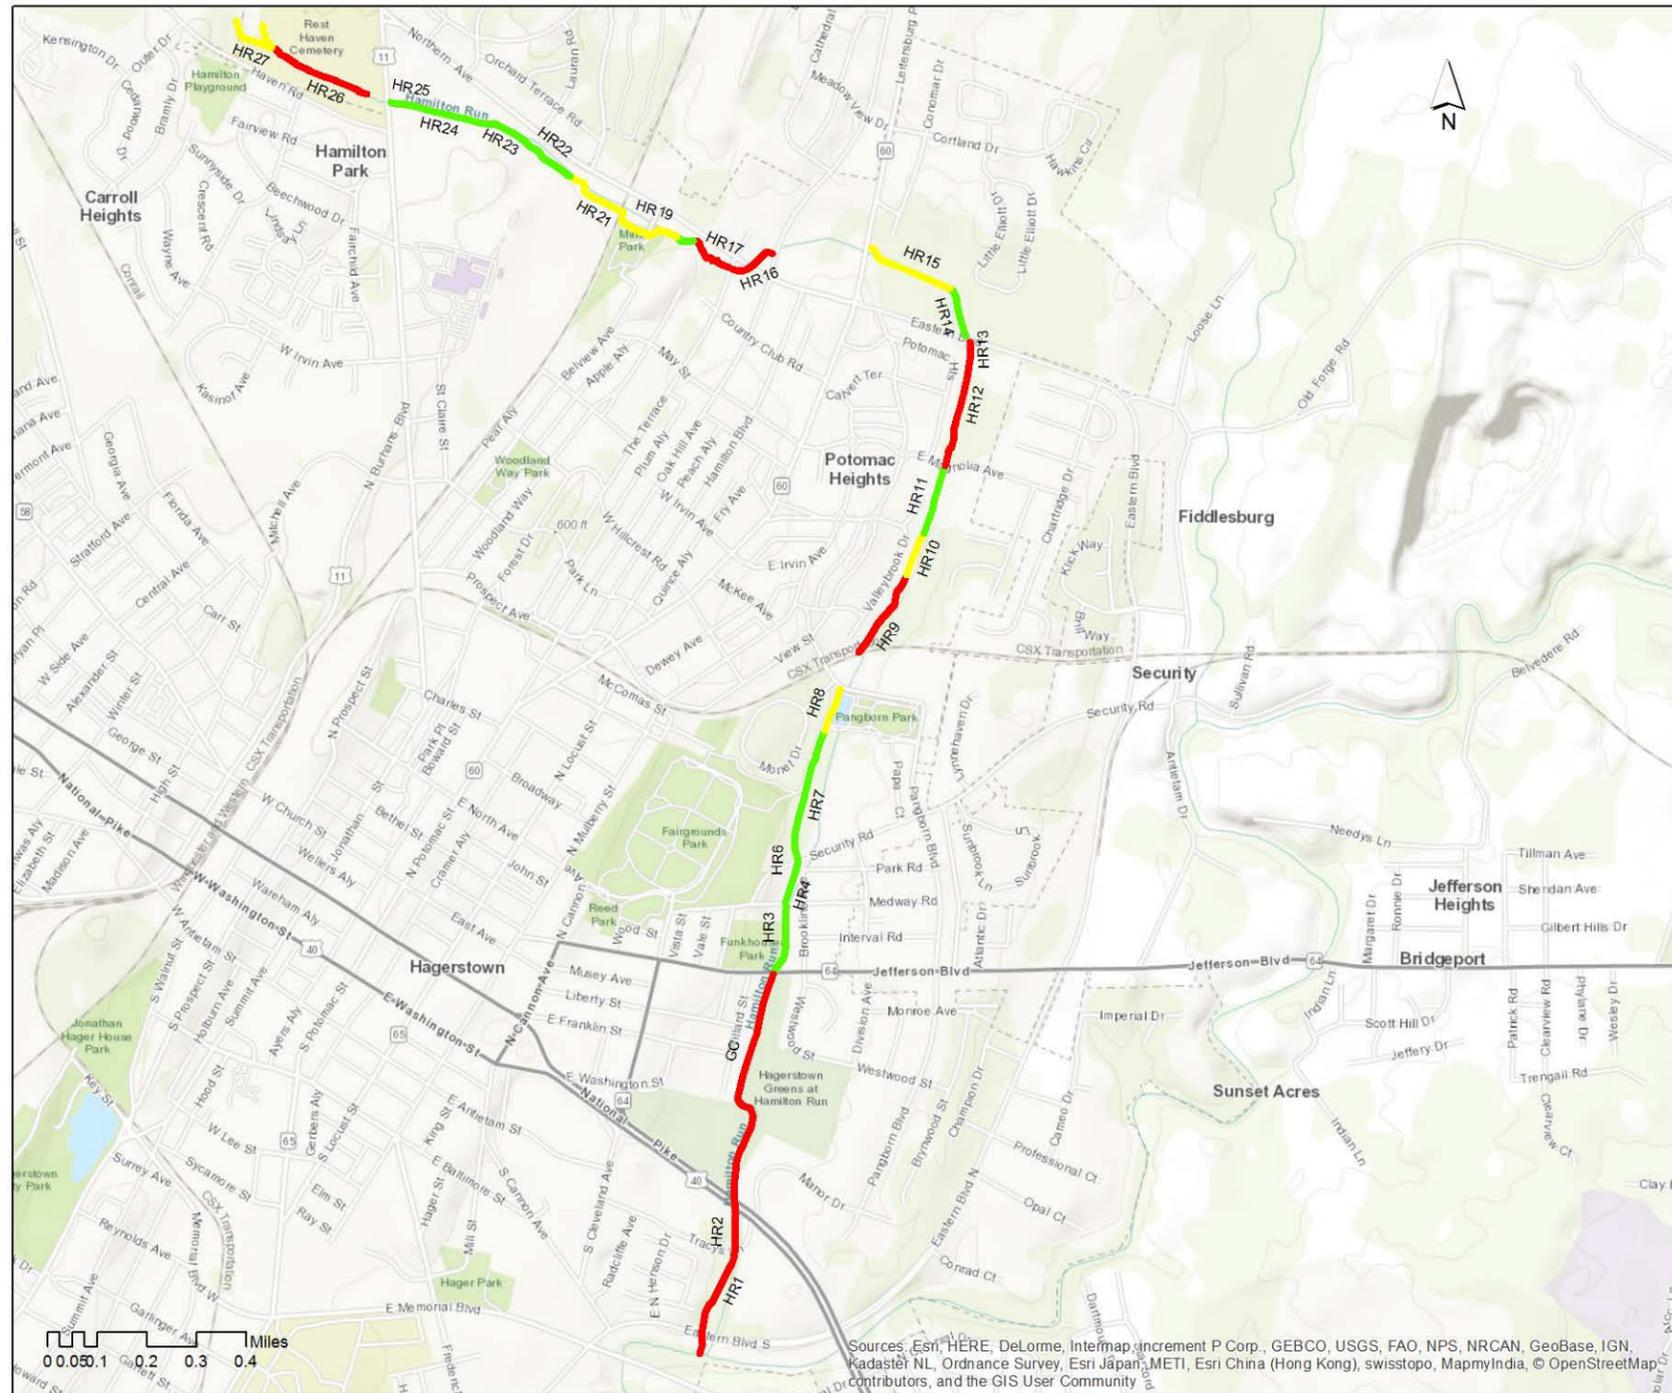
Hamilton Run Bank Erosion

The sediment supply being generated from the watershed runoff and eroding banks of Hamilton Run is moderate. The BANCS assessment characterized 125 eroding banks with a total length of 7,027 feet from the headwaters of Hamilton Run to the confluence with Little Antietam Creek, with a predicted erosion total of 822 tons of sediment per year (Table 1 - BEHI and NBS ratings and Predicted Erosion Amounts) (Figure 4 –Streambank Erosion). The dominant Bank Erodibility Hazard Index (BEHI) is moderate, while Near Bank Stress typically varied from Low to High across the reaches. Reference Appendix C – BANCS Assessment Data for a breakdown of collected field data. Across Hamilton Run, the assessment reaches were rated relative to each other in their annual production of sediment with assessment reaches producing less than ten tons of sediment per year rated low, assessment reaches producing between ten and forty tons per year rated moderate and assessment reaches producing greater than forty tons of sediment per year rated high. Additionally, the urbanized watershed and lack of riparian buffer allow sediment to be carried from adjacent lands into the stream during runoff events, increasing sediment load. To ensure long term stability of future stream restoration projects, channel design criteria should be developed to convey this sediment supply to reduce potential aggradation.

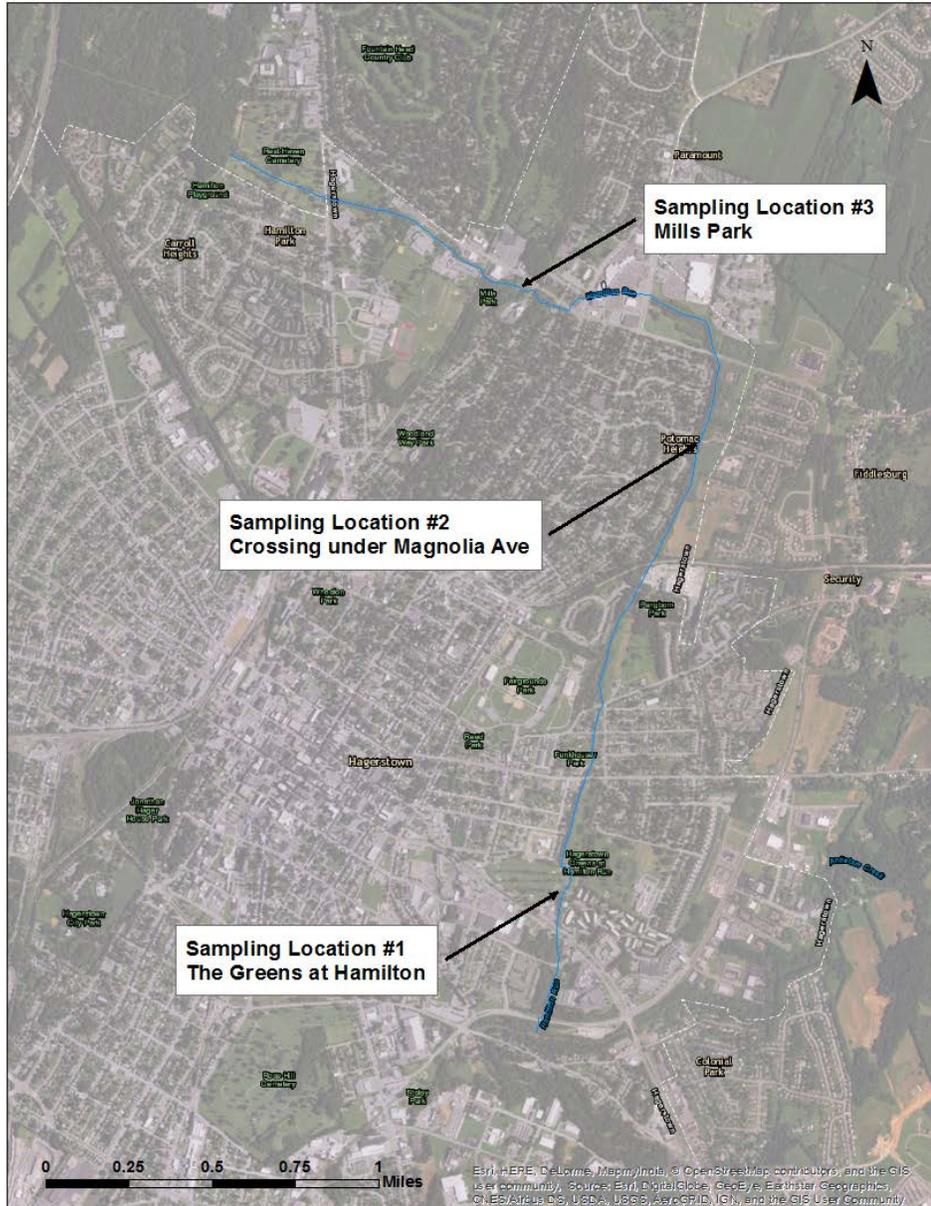
Figure 5. Water Quality Sampling Locations

Measurements for indicator bacteria of fecal coliform, E. Coli, were above quantification limits (> 2400 MPN / 100 mL) for 4 of the 6 sampling events, suggesting that water quality in Hamilton Run is degraded from E. Coli contamination. Fecal coliform is capable of being introduced into streams through both human and livestock pathways. Human introduction is mainly through either failing septic systems or leaking sewer pipes. There are currently minimal agricultural practices occurring within the watershed that suggests the source of fecal coliform is most likely from leaks in old sewer pipes.

Combining the water quality and sediment supply data, there is reason to suggest that sediment and fecal bacteria primarily impair the water quality in Hamilton Run. Additionally, urbanized watersheds are often impacted by a variety of pollutants that, while present in smaller quantities, are still capable of adversely affecting water quality. These pollutants, such as trace metals, gasoline byproducts, pesticides and herbicides, are accumulated as runoff makes its way over parking lots, roadways, and lawns (Shaver, Horner, Skupien, May, & Ridley, 2007; Center for

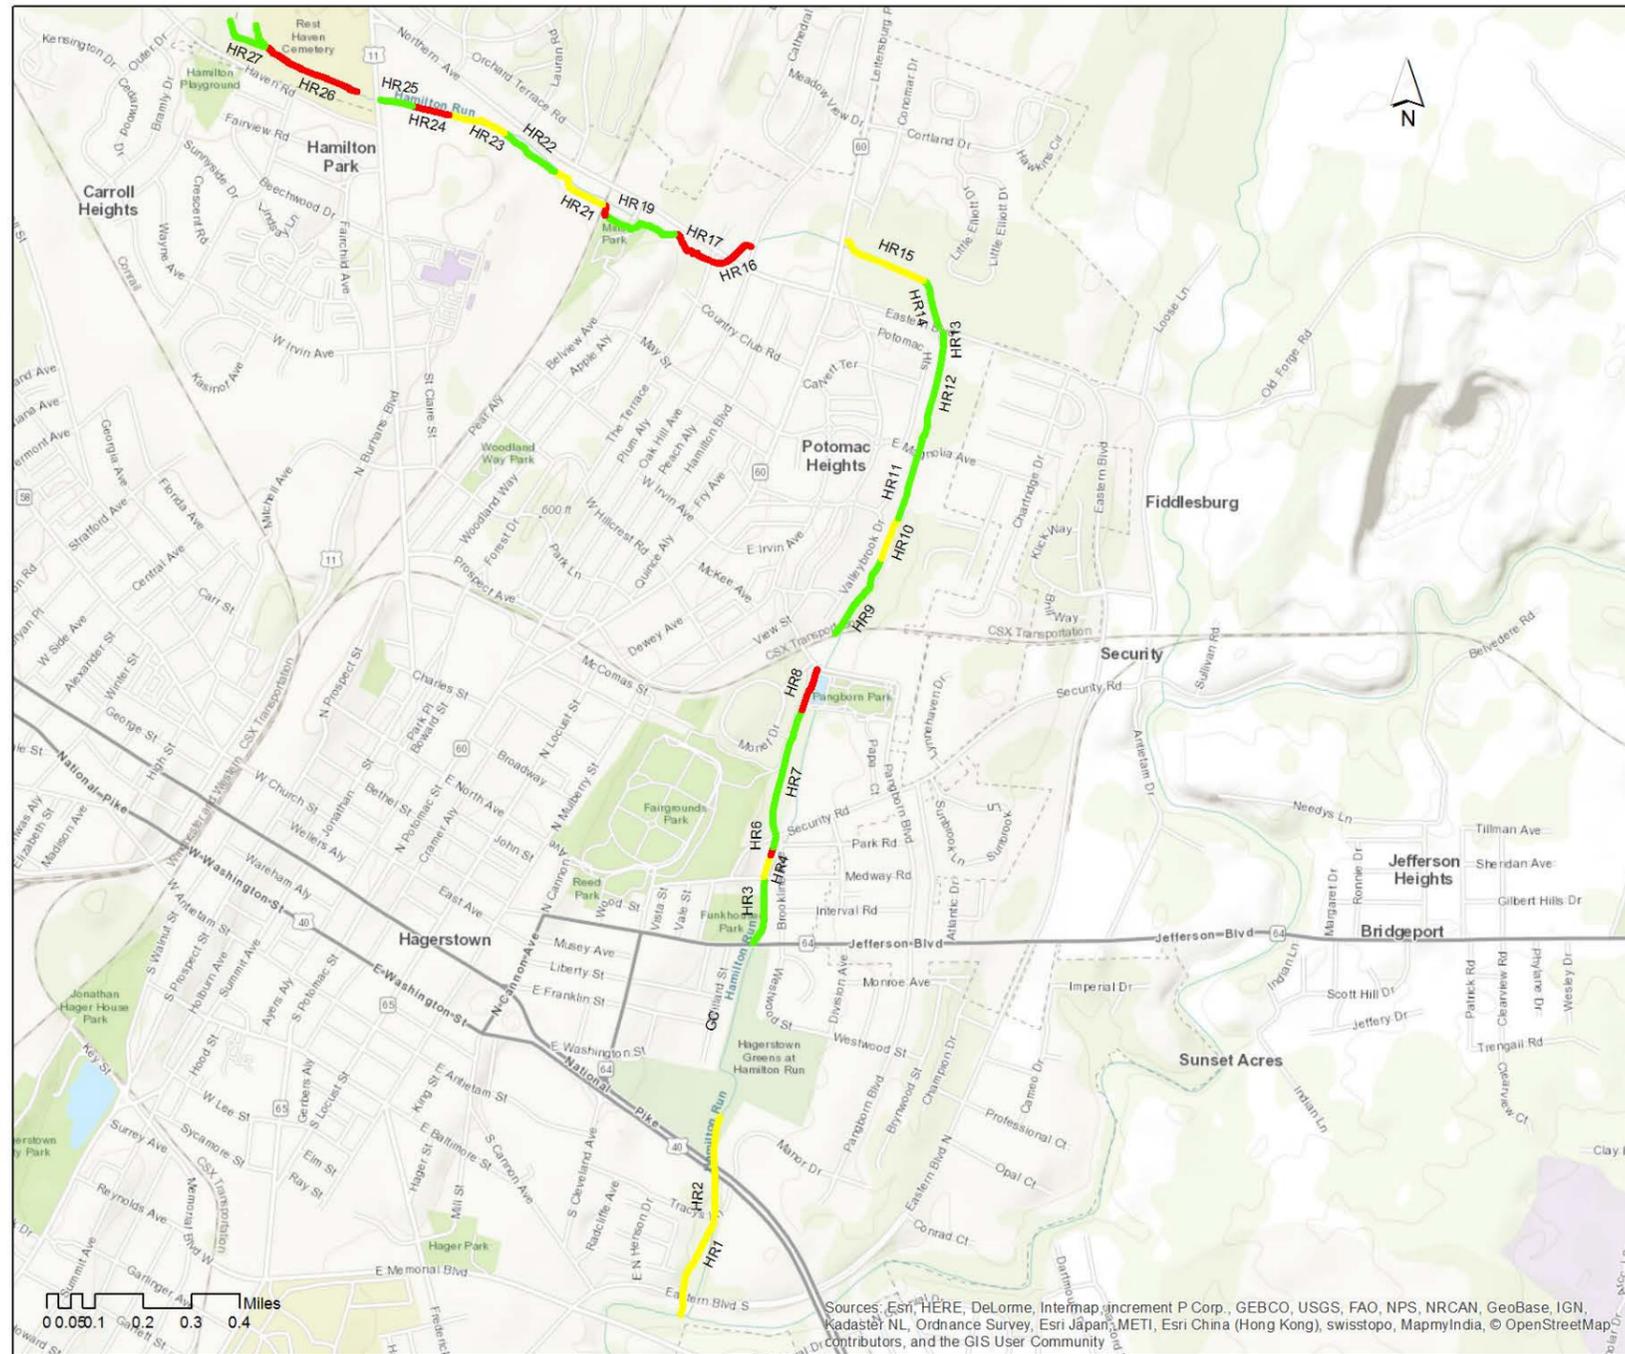
Hamilton Run Functional Rating

The reach level assessment conducted by EPR identified 27 distinct stream assessment reaches within the project area based on existing function-based stream conditions (Figure 6 – Assessment Reaches). A summary table listing the function-based conditions for each assessment reach is found below (Table 3 – Existing Function-Based Assessment). Assessment parameters were numerically scored to provide an objective measure of current conditions and potential uplift at each level of the Stream Functions Pyramid, described previously. From the individual pyramid level assessments, an overall function-based condition is then assigned to each assessment reach.

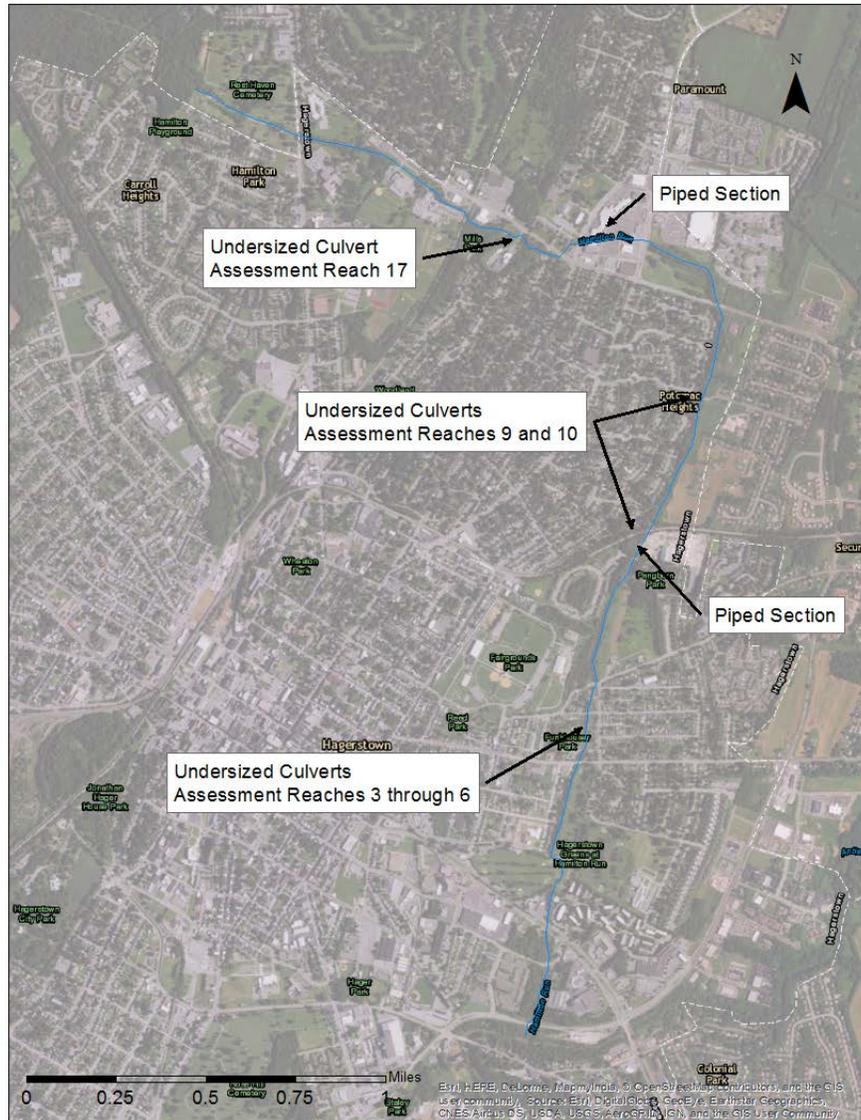
Figure 7. Project Constraints

Constraints are man-made features that may influence the restoration potential of a stream restoration project. There were four general project constraints identified across the reaches: 1) bridge / road crossings, 2) undersized culverts, 3) piped sections, and 4) encroachment by development (Table 10 - Constraints) (Figure 7 – Undersized Culverts and Piped Sections). These constraints are located throughout Hamilton Run and must be considered when evaluating the maximum potential functional uplift expected from a stream restoration project.

Bridges and culverts from road crossings are the most common constraints impacting 23 of the 27 reaches. Bridges and culverts impact the stream by altering flow dynamics and aquatic species movement. Flow dynamics are altered because bridges and culverts are typically undersized to pass stream flood flows. There are seven assessment reaches determined to be

impacted by culverts that cannot pass bankfull flows. These undersized culverts adversely impact stream conditions upstream and downstream. Upstream of undersized culverts, stream energy is reduced and causes a backwater build up that leads to stream bed aggradation and increased flooding. Downstream of undersized culverts stream energy is increased and causes stream bed and bank erosion. Aquatic species movement is adversely impacted either by significant bed elevation changes downstream of a culvert or because the culvert is too long.

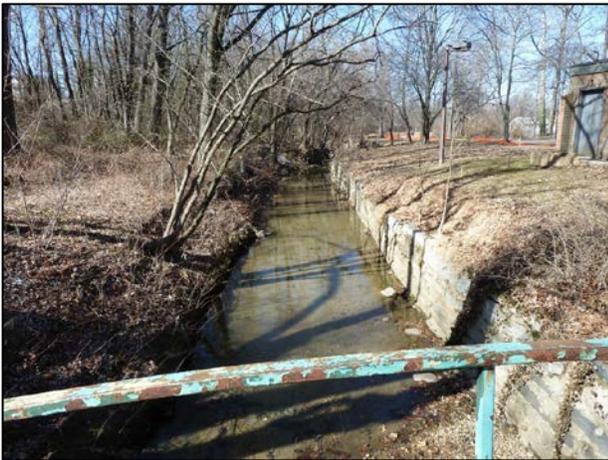
Figure 19. Existing Stream Condition
