Hamilton Run Watershed Characterization and Action Plan

April 26, 2017

Richard Starr
Ecosystem Planning and Restoration

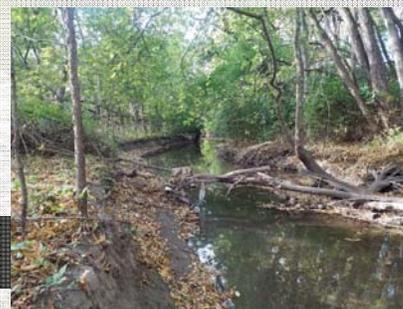
- Seven Evaluation Parameters:
 - Runoff
 - Floodplain Connectivity
 - Riparian Vegetation
 - Lateral Stability
 - Bedform Diversity
 - Water Quality and Nutrients
 - Biology
- Scoring - 1 (least functioning) through and 10 (highly functioning)
- Evaluated - Existing, restoration potential, and proposed conditions

Existing Condition	10	9	8
	Restoration Potential	10	9	8
	Proposed Condition	10	9	8

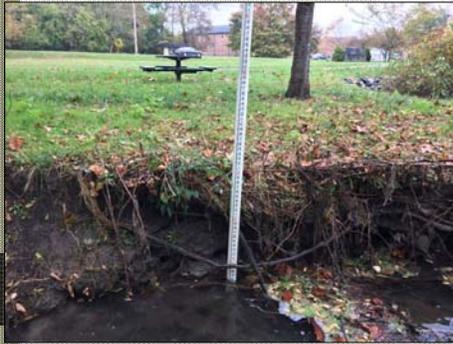
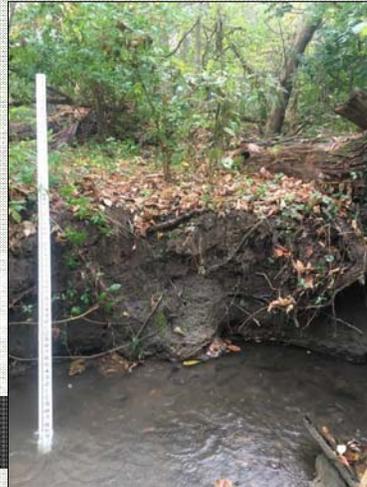
- Predict the rate and amount of streambank erosion
- Two Measurement Parameters
 - Bank Erodibility Hazard Index (BEHI)
 - Near Bank Stress (NBS) indices

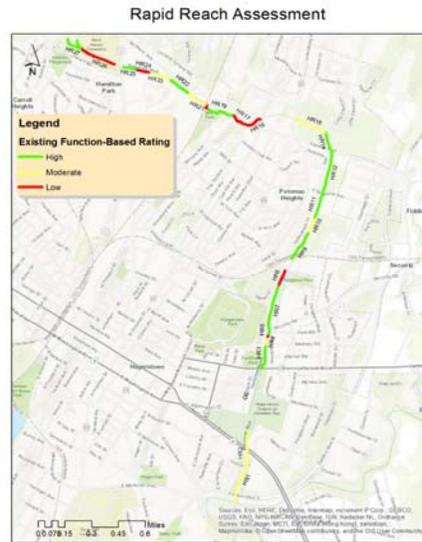
- Ratings relative based
- 49% High, 32% Moderate & 19% Low
- Primary impacts include:
 - Bank erosion
 - Poor bedform diversity
 - Lack of riparian vegetation
 - Poor floodplain connectivity
 - Untreated storm water runoff
 - Floodplain encroachment

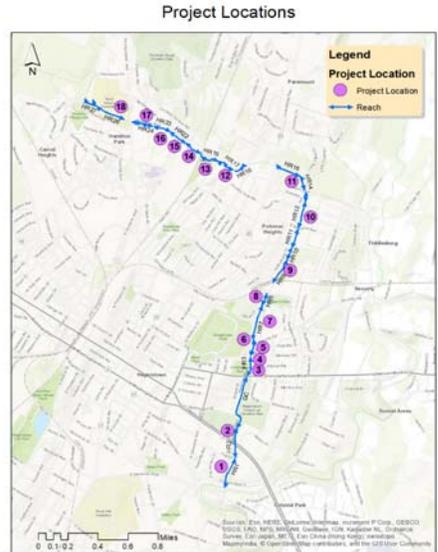
- Restoration Recommendations and Prioritization
- Natural Channel Design (NCD) stream restoration approach
- Storm water treatment and wetland BMPs
- 18 Proposed Project Areas

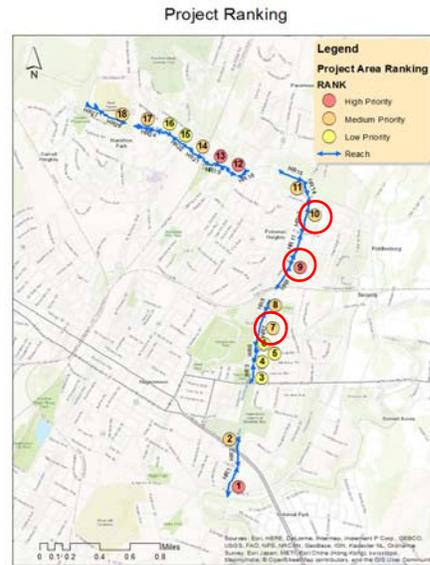
Priority Project Concept Plans – Project Area 7

- Stream fairly healthy
- Large open space on the left bank
- Create a wetland BMPs with stream channel to maintain moving water
- Filter Pangborn Pond water discharge
- Water quality and biological benefits
- Trail
- Need landowner permission

1. **Project 7** (downstream from the Pangborn Park lake)
2. **Project 9** (north/upstream from the RR embankment near Pangborn)
3. **Project 10** (just downstream from Eastern Blvd.)

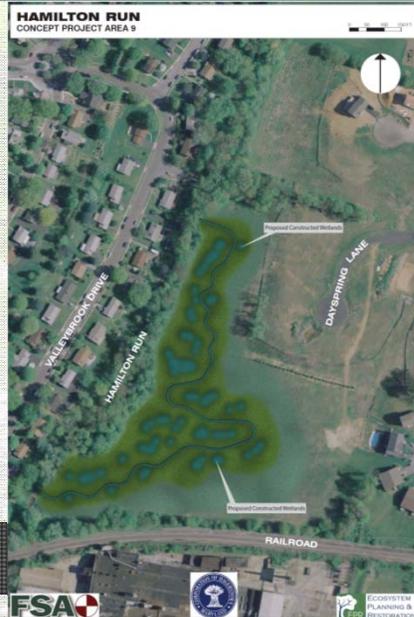
Priority Project Concept Plans – Project Area 9

- Large open space on the left bank (owned by school district)
- Create a wetland BMPs with stream channel to maintain moving water
- Highly eroding streambanks
- Need several landowners permission for stream restoration

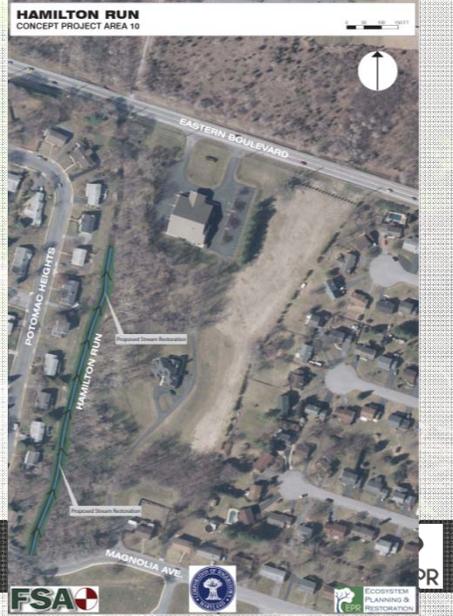
Priority Project Concept Plans – Project Area 10

- Highly eroding stream banks
- Priority 3 Stream Restoration
- Mostly water quality benefits with some biological benefits
- Need several landowners permission for stream restoration

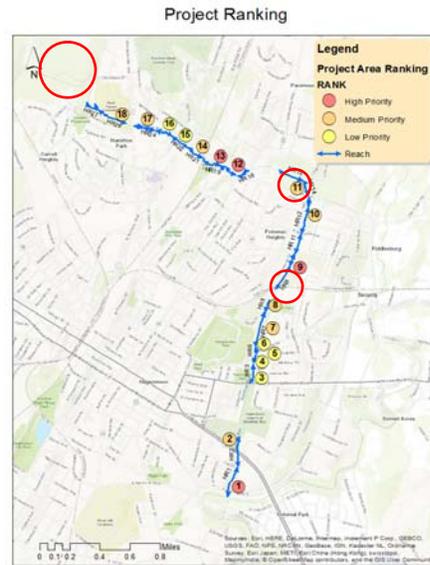
- Currently mixed zoning (high density residential development, professional office-mixed)
- Existing set aside for forest conservation easement
- Remaining land is in the Hamilton Run floodplain.
- Recommend large wetland BMP, with landowner support

- City of Hagerstown primarily built out
- High Density Development
- Redevelopment BMPs
- RAMP
- Two undeveloped areas
 - Project Area 11
 - Watershed headwater
- Pangborn Industrial Site

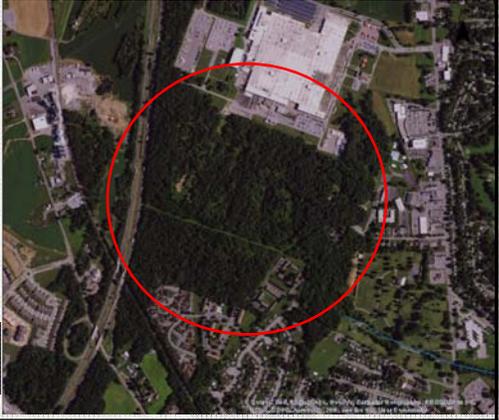
Watershed Headwaters

- Currently zoned high density
- Work with landowner
 - Preserve forest *or*
 - Limit impervious cover

An aerial photograph showing a watershed headwater area. A red circle highlights a large, dense forested area. To the north and east of the forest are several large, light-colored industrial or commercial buildings. The surrounding area includes residential neighborhoods with houses and streets, and a road that runs along the edge of the forest.

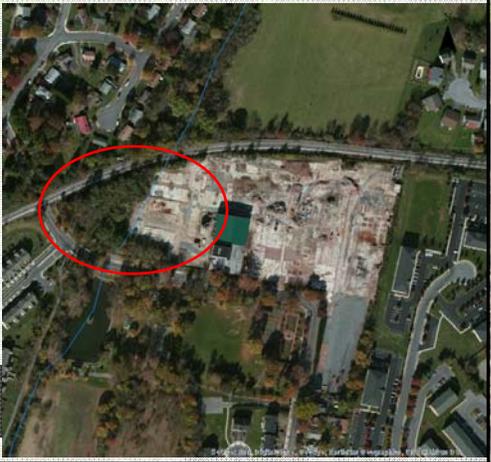
Pangborn Industrial Site

- Work with landowner
 - Remove concrete areas
 - Reforest floodplain
 - Daylight Hamilton Run

An aerial photograph of the Pangborn Industrial Site. A red circle highlights a specific area within the site, which appears to be a mix of industrial buildings and open land. The site is surrounded by residential areas with houses and streets. A road runs along the top edge of the site, and a stream or floodplain is visible to the left.
